Evaluation of Nondestructive Methods for Determining Pavement Thickness

Lulu Edwards and Quint Mason

September 2011

Final report

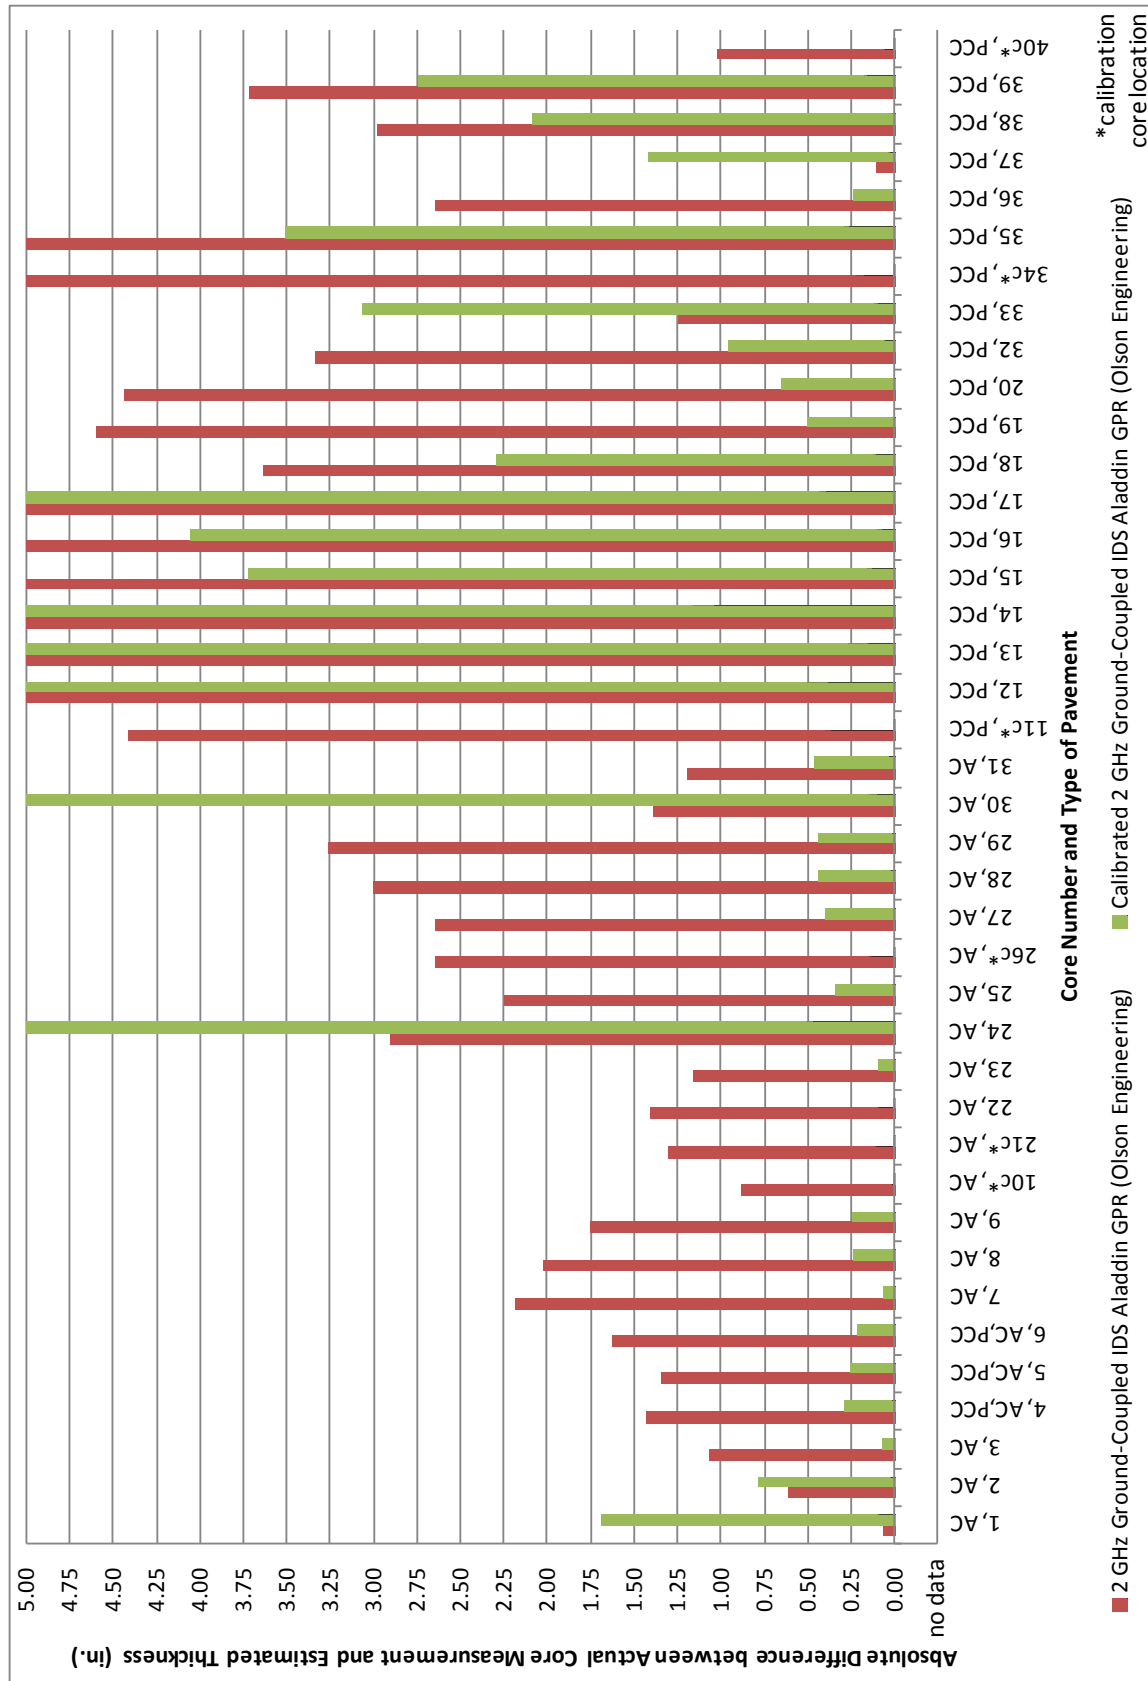
Figure A4. Comparison of the estimated thicknesses using the 2-GHz ground-coupled IDS Aladdin GPR (Olson Engineering) to actual core thicknesses.

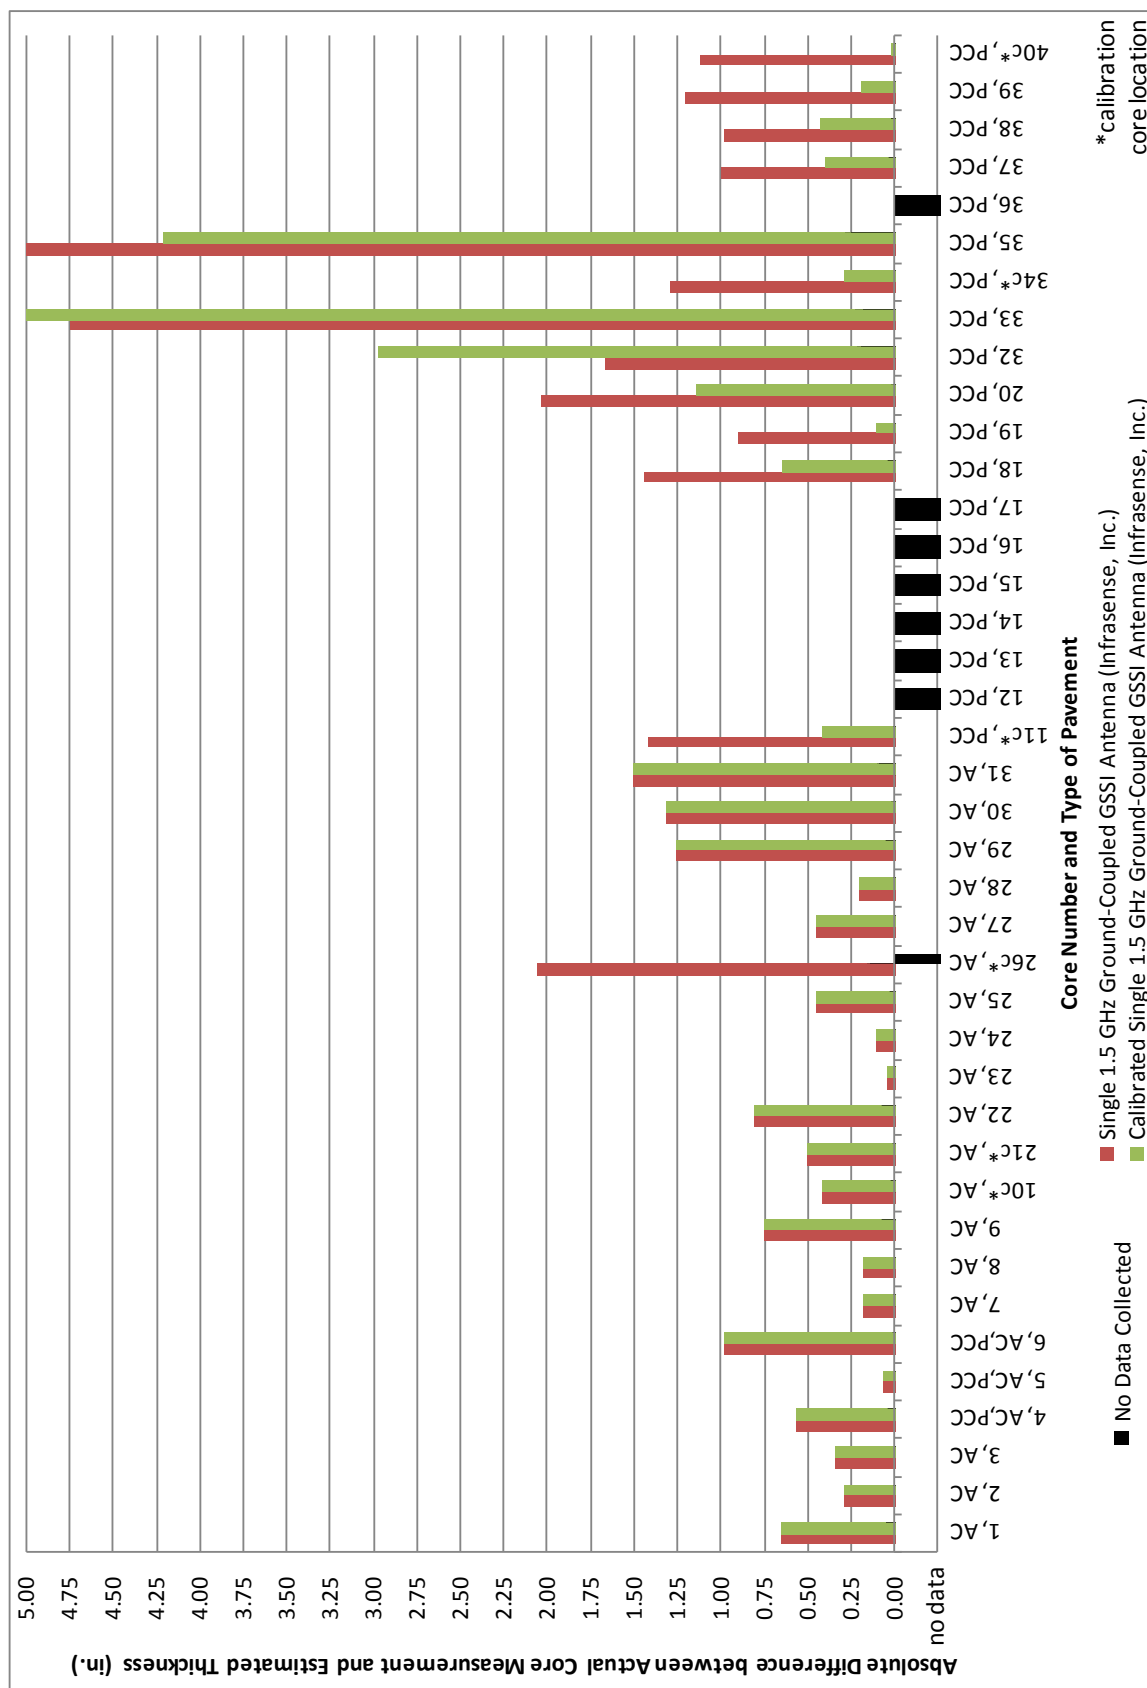
Figure A5. Comparison of the estimated thicknesses using the single 1.5-GHz ground-coupled GSSI antenna (Infrasense, Inc.) to actual core thicknesses.

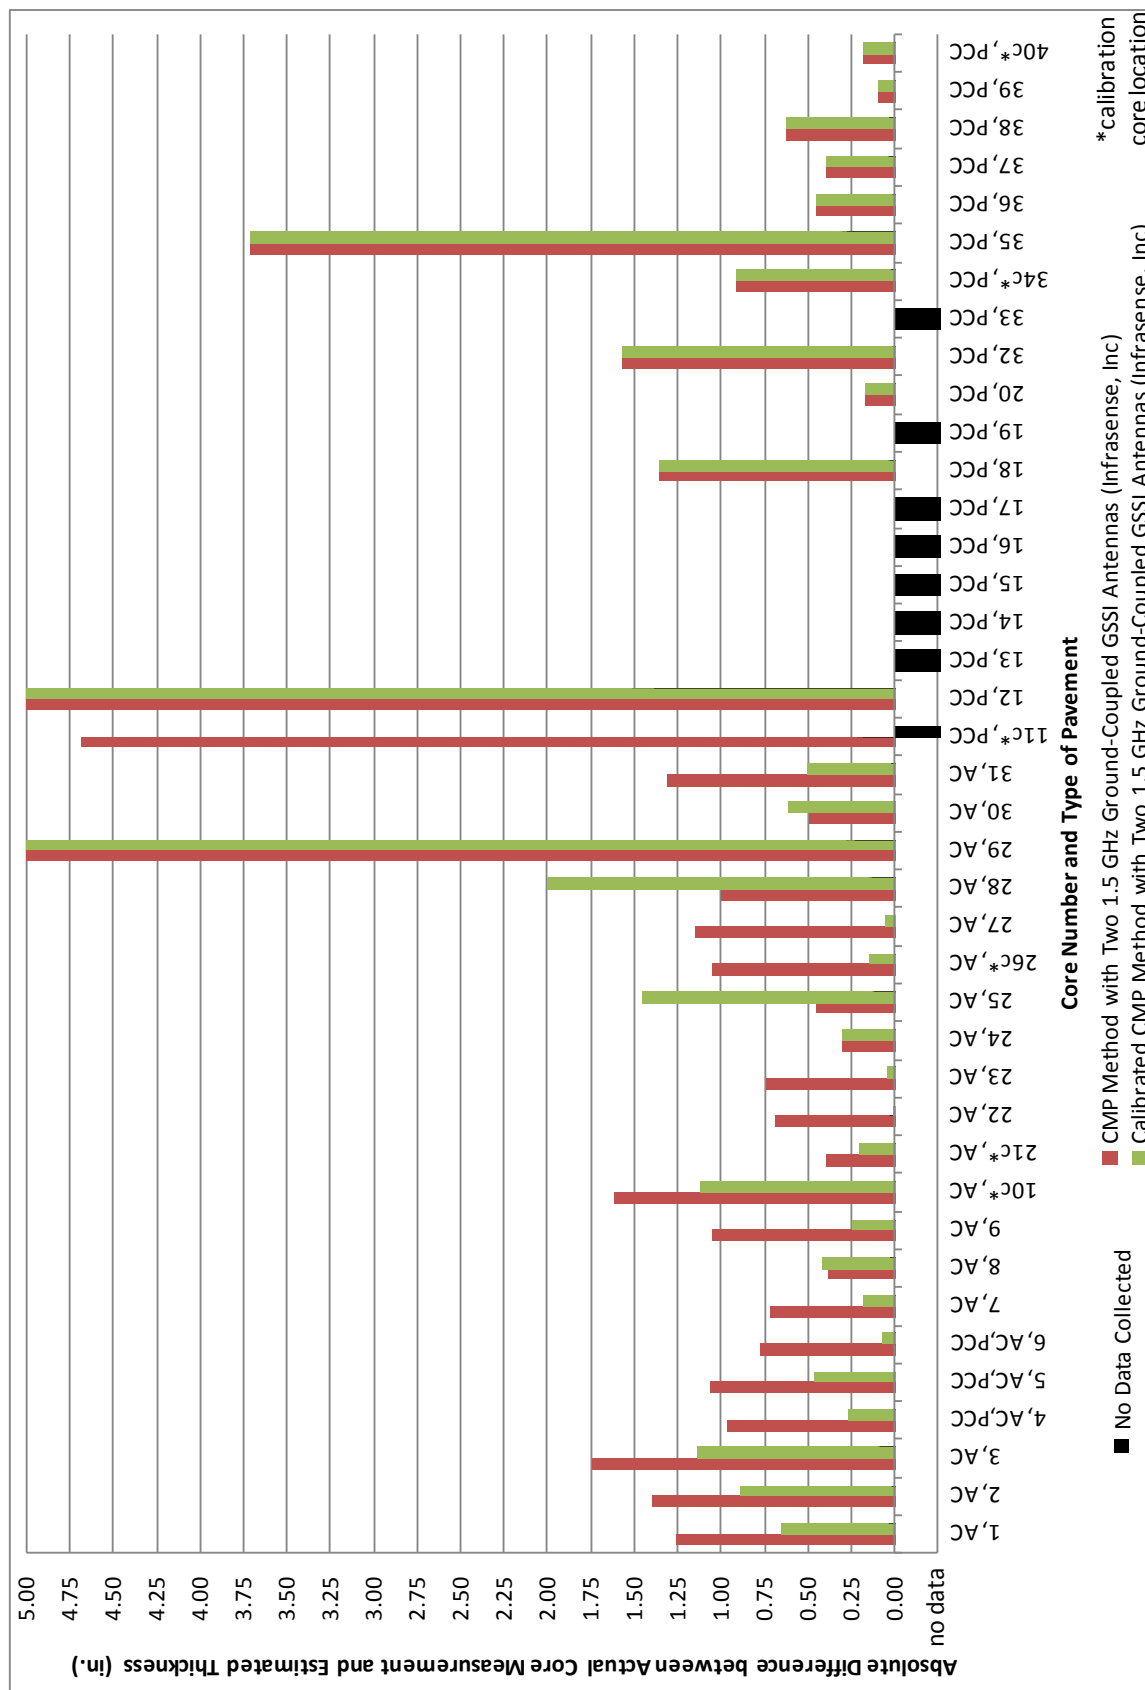
Figure A6. Comparison of the estimated thicknesses using the CMP method with two 1.5-GHz ground-coupled GSSI antennas (Infrasense, Inc.) to actual core thicknesses.

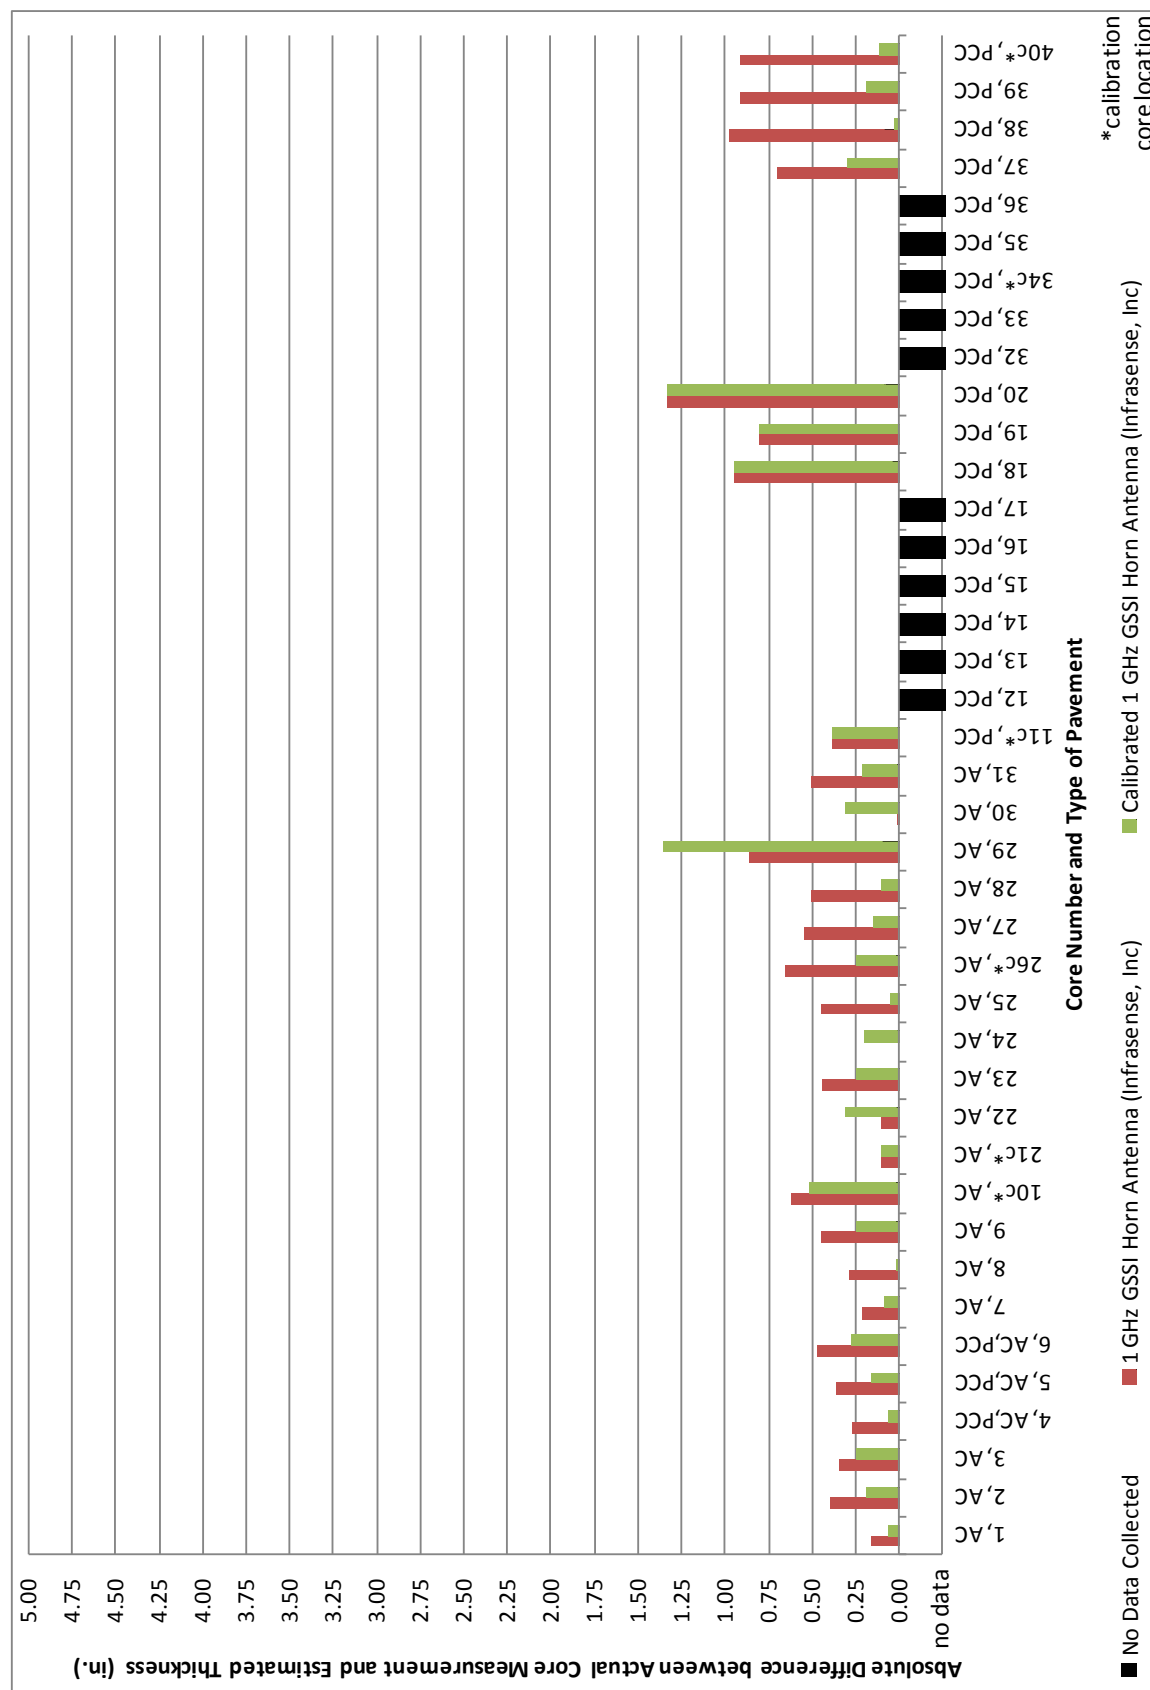
Figure A7. Comparison of the estimated thicknesses using the 1-GHz GSSI horn antenna (Infrasense, Inc.) to actual core thicknesses.

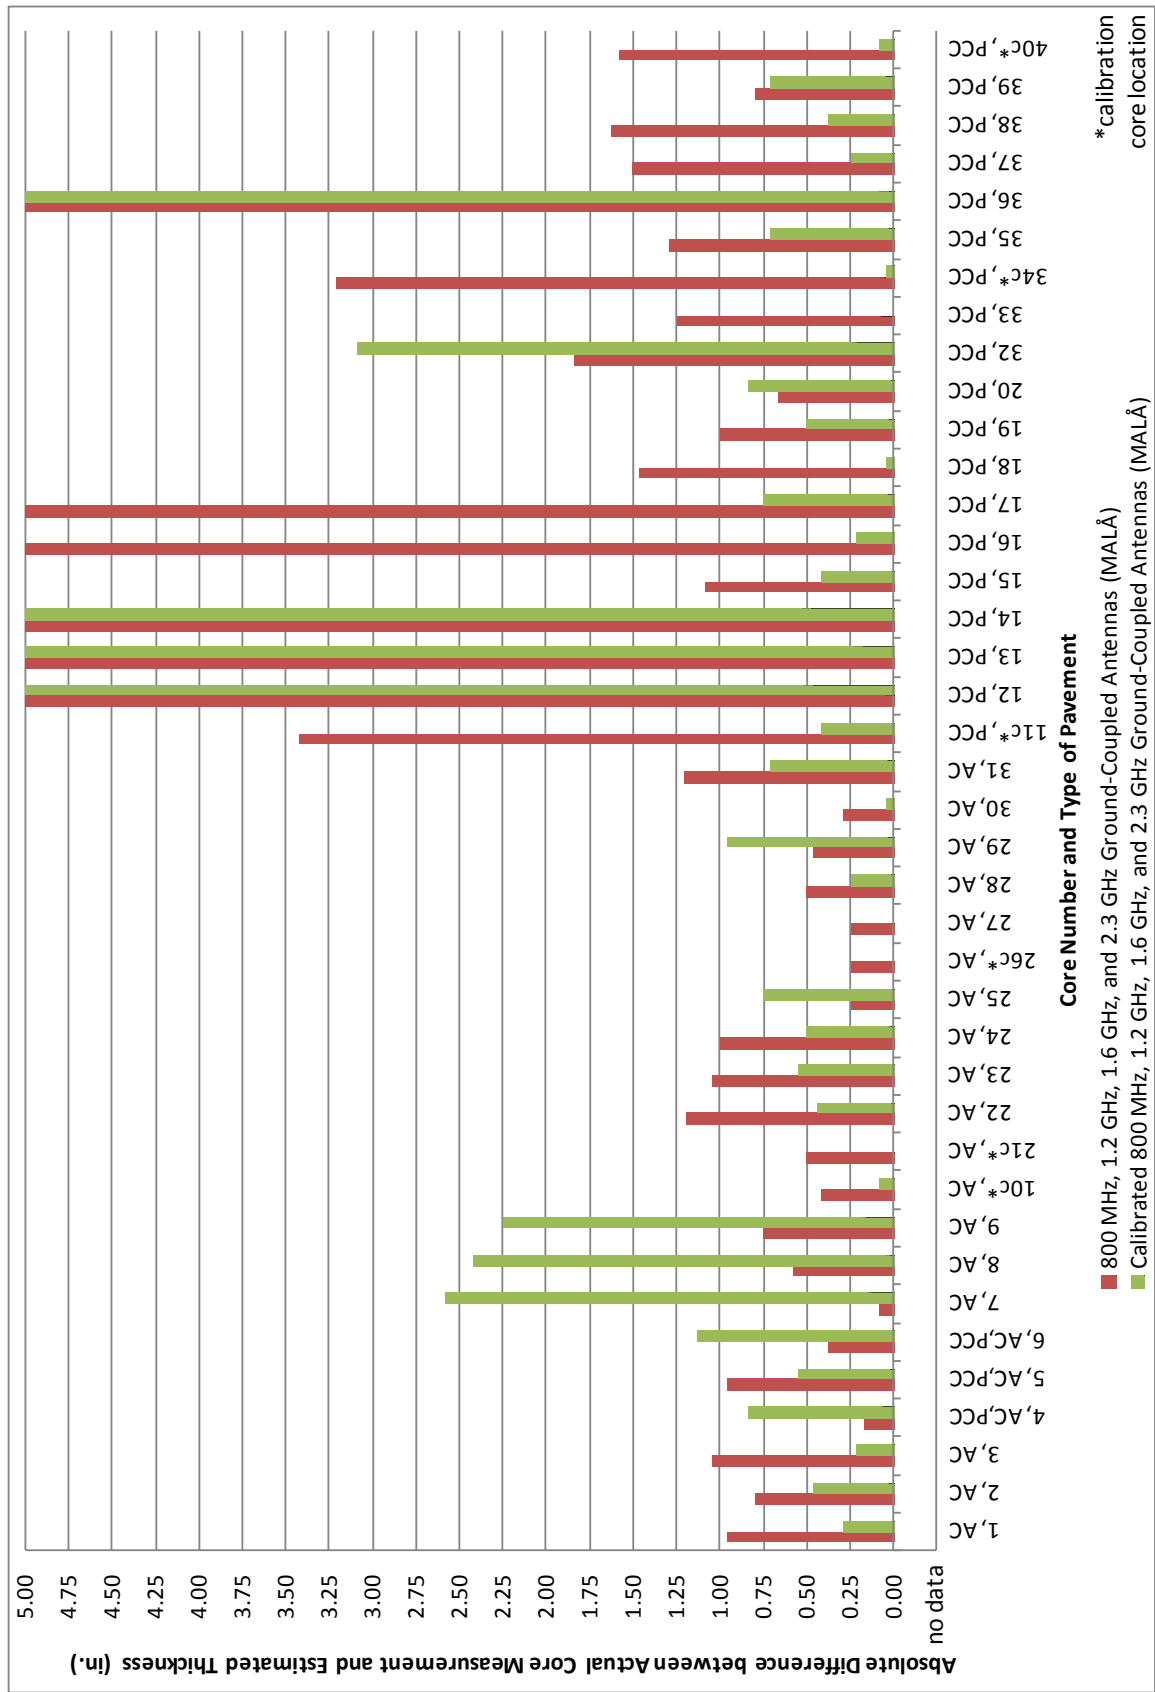
Figure A9. Comparison of the estimated thicknesses using the 800-MHz, 1.2-GHz, 1.6-GHz , and 2.3-GHz ground-coupled GSSI antennas (MALA) to actual core thicknesses.

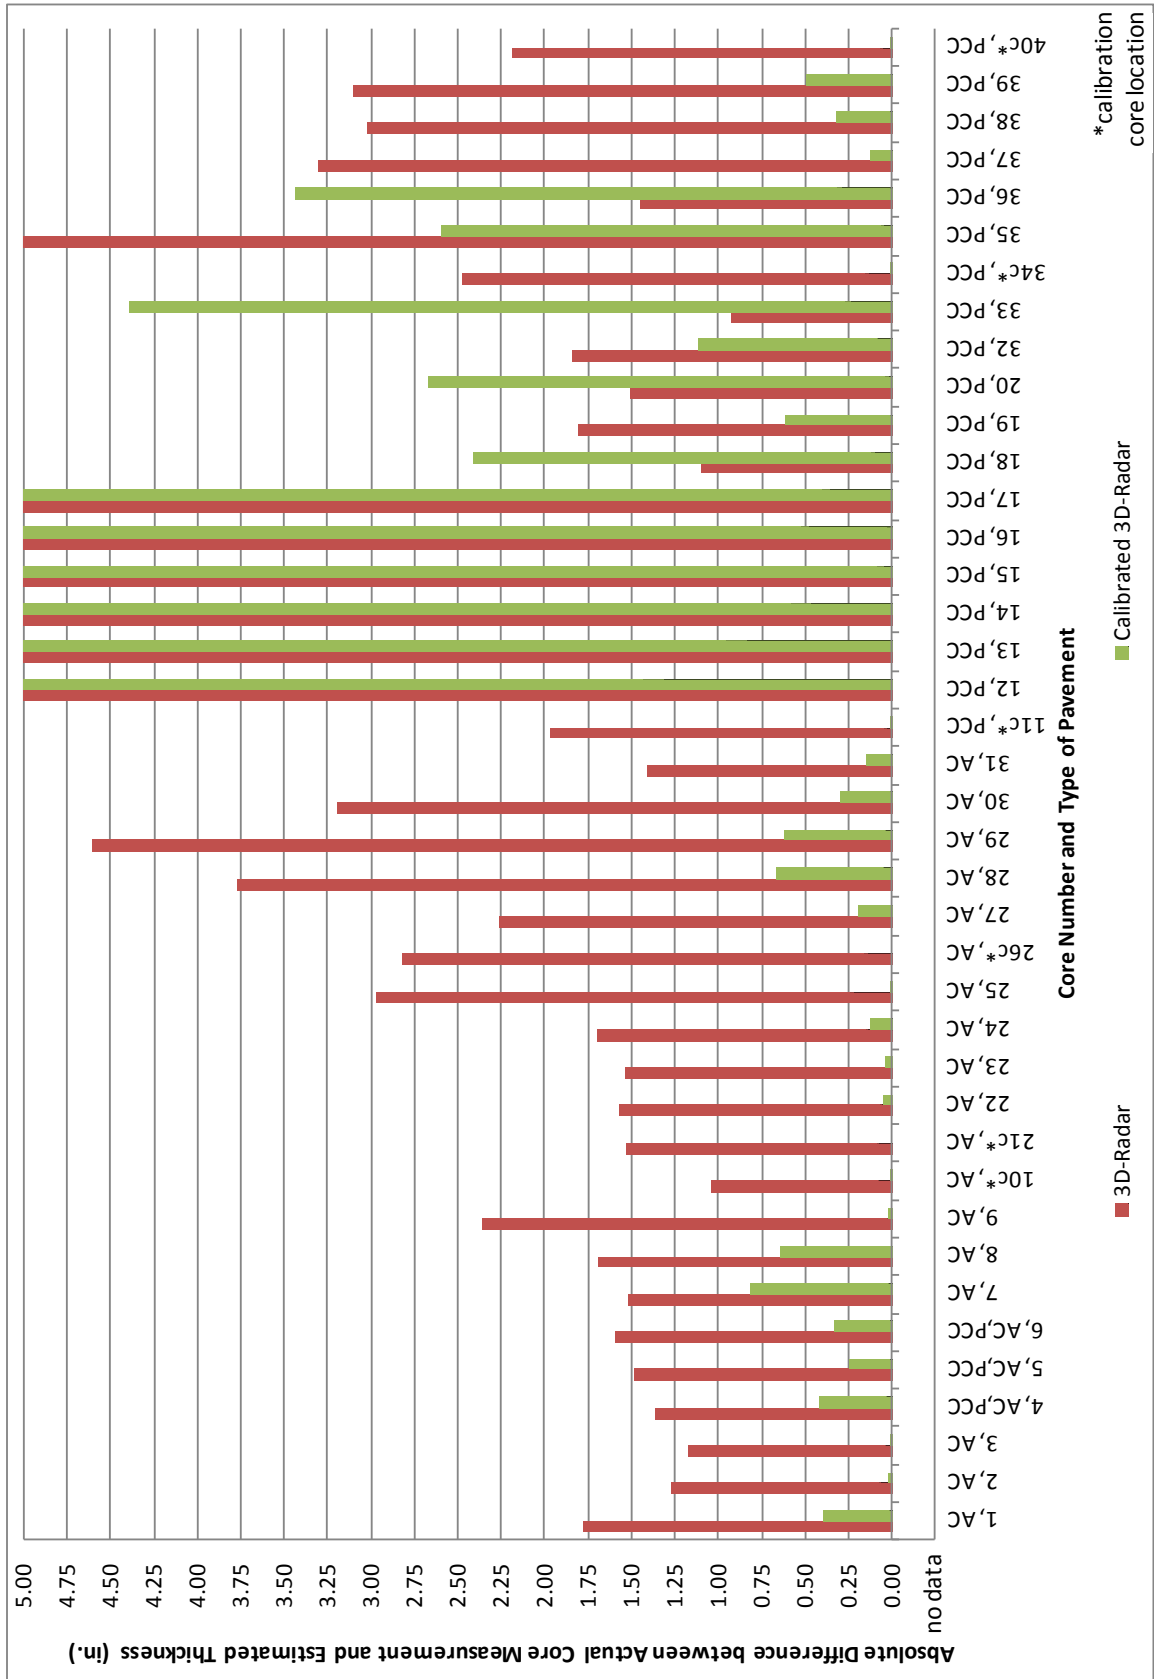
Figure A10. Comparison of the estimated thicknesses using the 3D-Radar device to actual core thicknesses.

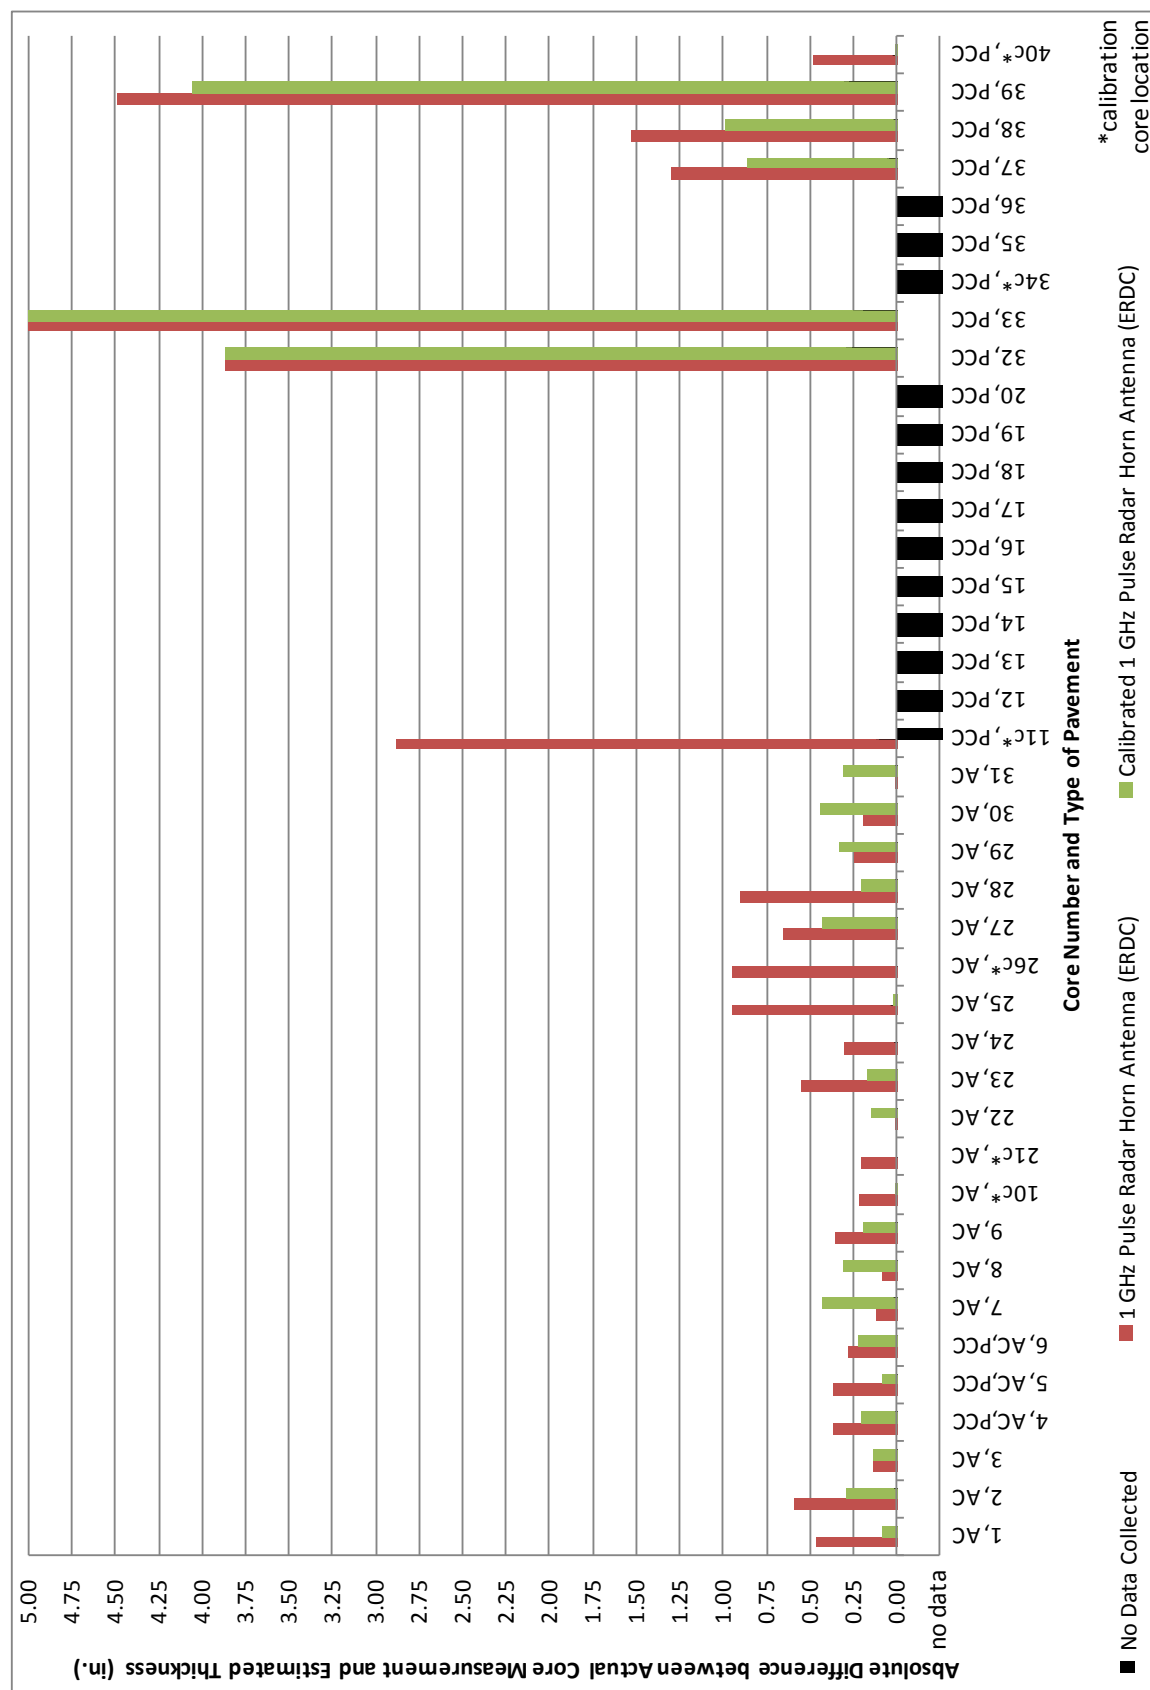
Figure A11. Comparison of the estimated thicknesses using the 1-GHz Pulse Radar horn antenna (ERDC) to actual core thicknesses.
